Flexible **H**eat and **P**ower, connecting heat and power networks by harnessing the complexity in distributed thermal flexibility

### **D4.3 Ecovat validation**

Version number:1.0  
Dissemination Level: PU  
Lead Partner: Ecovat  
Due date: 30-Jun-2019  
Type of deliverable: Demonstrator  
Status: Final

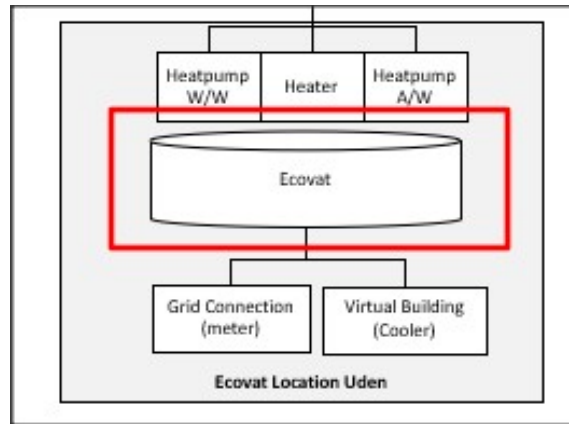
Figure 5: Ecovat vessel

<b>Measurement</b>	<b>Quantity</b>	<b>Unit</b>
Diameter of water column	11	m
Outside diameter	13	m
Height of water column	15.5	m
Number of thermal layers	5	
Number of elements per layer	11	
Maximum temperature	90	°C

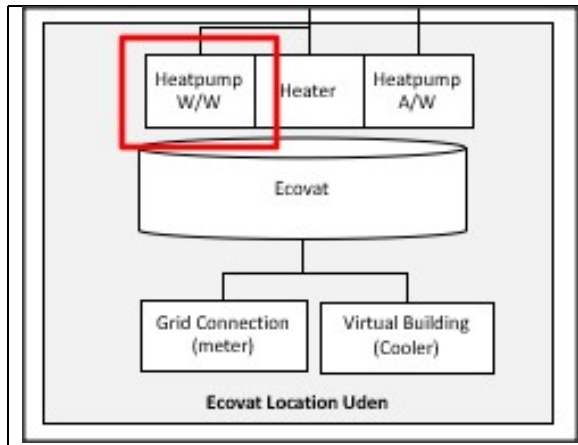
Figure 6: Ecovat water water heat pump

The Ecovat is equipped with two heat pumps, one NIBE F1155-12 and one NIBE F2120-12.

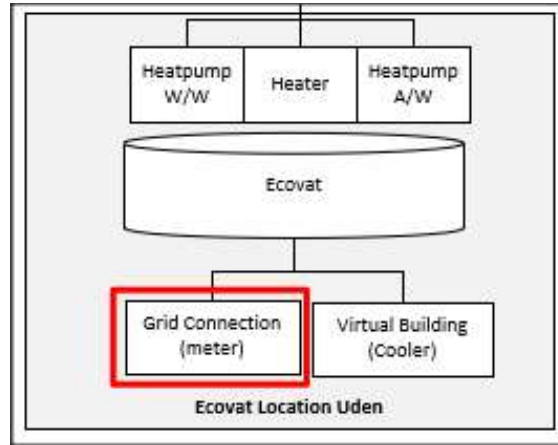
Figure 9: Ecovat grid connection

The Ecovat is connected to the grid through 3 × 250 A feeders through a medium to low voltage substation.

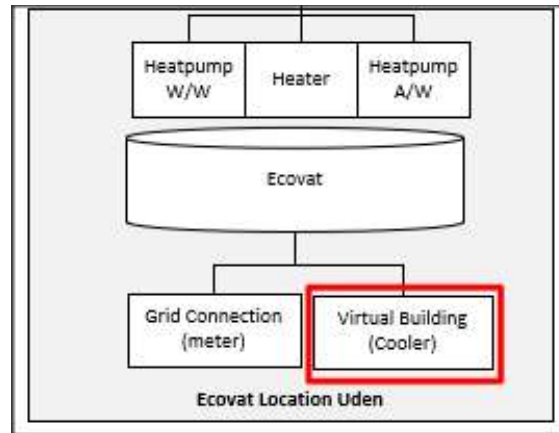
**Figure 11: Ecovat dry cooler**

The heat demand is simulated by means of a Horizontal Thermofin Drycooler with 2 × 910 mm fans.

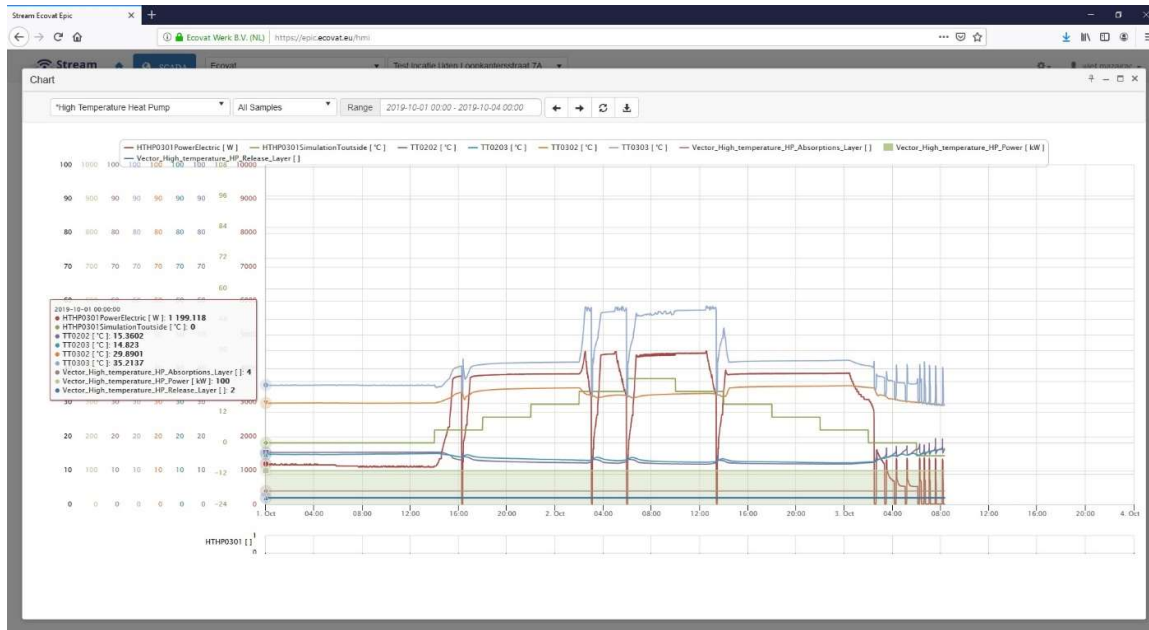
Figure 17: Test with tag "2019\_10\_03\_02\_wwhp\_steps"

- 13h00: After stabilization of the heat pump the simulated outdoor temperature sensor value is increased by 5 degrees every 4 hours.
- 13h00-08h00: The amount of electric power consumed is erratic. During this period the power drops to 0 at 3 moments after which the heat pump increases its power consumption again. Every 4 hours the control signal is changed. In this period only 2 levels of power consumption can be observed (3800 Watts and 4400 Watts).
- 08h00-06h00: Every 4 hours the control signal decreases with 5 degrees Celsius. The electric power consumption of the heat pump decreases, however a step function is difficult to observe.

The water-water heat pump reacts to the control signal. It turns on when the control signal goes up and it turns off when the control signal goes down. Also, different levels of power consumption can be observed. It is not possible however to relate the exact value of the control signal with the amount of electricity consumed by the heat pump.

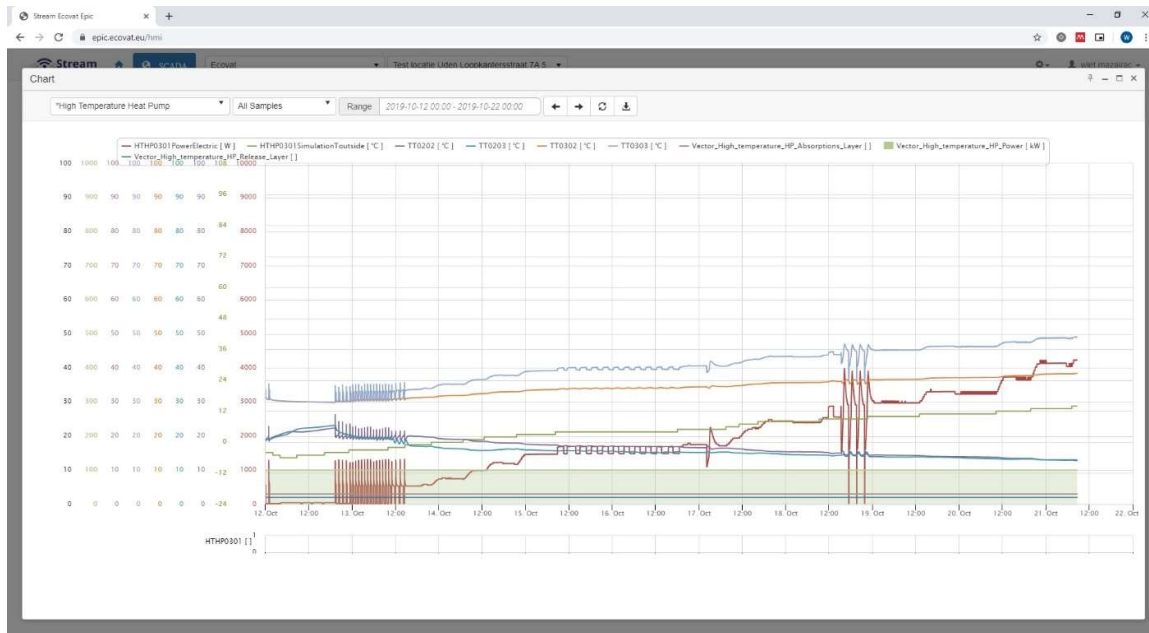
Figure 20: Test with tag “2019\_10\_21\_01\_wwhp\_long\_interval\_1c\_incomplete”

- 14/10 0h00 – 15/10 0h00: Simulated outdoor temperature is increased after heat pump stabilization. Heat pump starts ramping up within 30 minutes.
- 15/10 06h00 – 16/10 18h00: Electric power consumption is not continuous, instead a square wave can be observed.

- 16/10 18h00 – 18/10 12h00: The simulated outdoor temperature is increases each time after stabilization of the heat pump occurs. A dip and peak can be observed around 16/10 04h00. The reason for this is unknown.

- 18/10 10h00 – 18/10 23h00: After increasing the control signal (simulated outdoor temperature) erratic behaviour of the heat pump is observed. The heat pump oscilates between zero and full power. After increasing the

simulated outdoor temperature again, at 18/10 23h00, this behaviour disappears.

- 19/10 0h00 – 21/10 08h00: The simulated outdoor temperature is increased each time after stabilization of the heat pump. The heat pumps reacts by starting to ramp up within half an hour.

A square wave can be observed when the heat pump is at low power. The duty cycle increases when the required power increases. Halfway during the test another square wave was observed. The reason for this square wave is unknown.

At two thirds of the test oscillating behaviour was observed. The reason for this behaviour is also unknown.
